## CAFO WPDES Compliance Report (07-21-14)

Inspection date: 07-10-14

Inspection type: Compliance, follow-up

Operation Name: New Horizons Dairy LLC

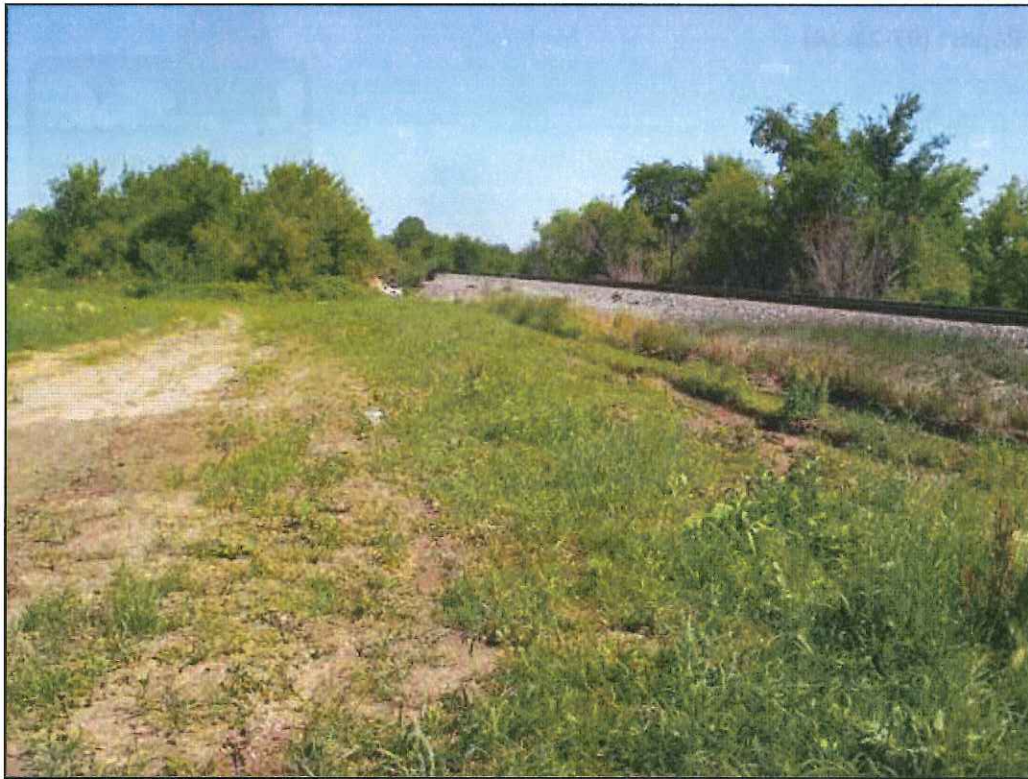
Feed Storage and Leachate Collection— Bean silage stored in grassy area along southern border of production area had been removed and the area had been cropped (Photo 1). Van De Hey stated that this silage was fed out less than a week after the April inspection. Plastic-covered hay previously observed along the railroad tracks had also been removed or feed out (photo 2). No runoff was apparent from these areas.

**Photo 2.** Former plastic-covered hay storage area.
